WHEN ORDERING REPLACEMENTS. STATE SERIAL NUMBER AND SIZE STAMPED ON NAME PLATE OF MACHINE AND DESIGNATE PART BY BOTH NAME AND NUMBER

ADJUSTMENT FOR SIDE WEAR

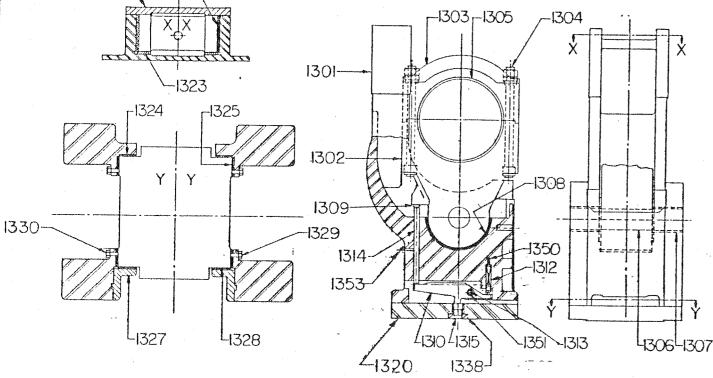
1301 RAM

1302 PITMAN

1303 PITMAN CAP

1304 PITMAN BOLTS

1305 PITMAN AND CRANKSHAFT BUSHING

1306 PITMAN WRIST PIN

1307 PITMAN WRIST PIN BUSHINGS

1308 RAM THRUST BUSHING

1309 PITMAN KICKER LUG INSERT

1310 UPPER KNOCKOUT LEVER

1312 UPPER KNOCKOUT SPRING
1313 UPPER KNOCKOUT LEVER FULCRUM PIN . 1351 LEVER BUSHING

1314 UPPER KNOCKOUT DRIVE PIN

1315 UPPER KNOCKOUT KICKER PIN

1320 RAM PLATE

1321 RAM EXTENSION COVER PLATE

1322 RAM EXTENSION SIDE LINERS

1323 RAM EXTENSION REAR LINERS

1324 FRAME REAR LINERS

1325 FRAME SIDE LINERS

1327 FRONT GIBS-RIGHT AND LEFT HAND

1328 FRONT GIB LINERS

1329 RIGHT SIDE LINER SCREWS

1330 LEFT SIDE LINER SCREWS

1338 KICKER PIN RETAINER

1350 SPRING ROD WITH COLLARS

1353 DRIVE PIN RETAINER

2. LOOSEN SCREWS (1329 & 1330) IN SIDE OF PRESS FRAME AND REMOVE LINERS (1325).

3. INSTALL SUITABLE SHIMS TO FIT BETWEEN THE LINER (1325) AND BED ALLOWING APPROX. .0006" PER INCH OF RAM WIDTH FOR RUNNING CLEARANCE AND REPLACE LINERS REVERSING THE ABOVE PROCEDURE.

5. TO COMPENSATE FOR FRONT TO BACK WEAR ON BEARING OF THE RAM EXTENSION, LINERS (1323) MAY BE REMOVED, AND SUITABLE SHIMS INSTALLED BETWEEN THEM AND THE FRAME, AND IF NECESSARY, REMOVE SHIMS OF THE PROPER THICKNESS FROM UNDER THE EXTENSION COVER PLATE (1321)

. NEVER INCREASE KICK BEYOND MAXIMUM STROKE (PER TOOL & DIE SPACE) SINCE THAT WILL CAUSE FAILURE IN UPPER KNOCKOUT MECHANISM.
