WHEN ORDERING REPLACEMENTS, STATE SERIAL NUMBER AND SIZE STAMPED ON NAME PLATE OF MACHINE AND DESIGNATE PART BY BOTH NAME AND NUMBER

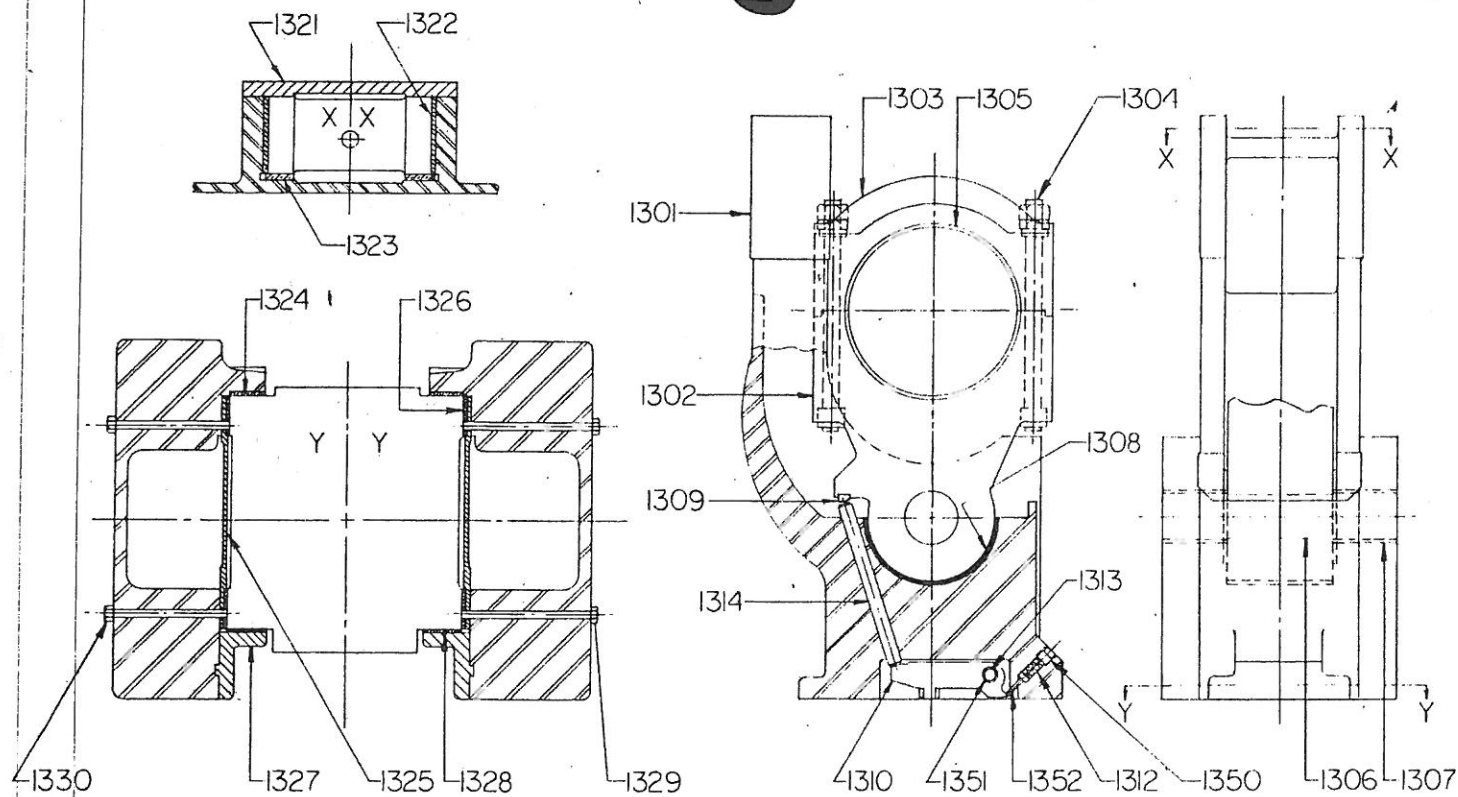
ADJUSTMENT FOR SIDE WEAR

- 1 REMOVE GIBS (1327).
- 2 LOOSEN SCREWS (1329 & 1330) IN SIDE OF PRESS FRAME AND REMOVE LINERS (1325).
- 3 INSTALL SUITABLE SHIMS TO FIT BETWEEN THE LINER (1325) AND LINER INSERT (1326), ALLOWING APPROX. .0005" PER INCH OF RAM WIDTH FOR RUNNING CLEARANCE AND REPLACE LINERS, REVERSING THE ABOVE PROCEDURE.

ADJUSTMENT FOR FRONT TO BACK WEAR.

- 4 REMOVE LINERS (1328) AND INSTALL SUITABLE SHIMS BETWEEN THEM AND FRONT GIBS (1327). ALSO REMOVE LINERS (1324) AND INSTALL SUITABLE SHIMS BETWEEN THEM AND FRAME. ALLOW OPERATING CLEARANCE OF APPROX. .0005" PER INCH OF RAM WIDTH.
- 5 TO COMPENSATE FOR FRONT TO BACK WEAR ON BEARING OF THE RAM EXTENSION, LINERS (1323) MAY BE REMOVED, AND SUITABLE SHIMS INSTALLED BETWEEN THEM AND THE FRAME, AND IF NECESSARY, REMOVE SHIMS OF THE PROPER THICKNESS FROM UNDER THE EXTENSION COVER PLATE (1321).

UPPER KNOCKOUT ADJUSTMENT

- 6 UPPER KNOCKOUT HAS BEEN SET FOR MAXIMUM STROKE. TO REDUCE THIS STROKE, MACHINE OFF PITMAN KICKER LUG INSERT (1309).

NEVER INCREASE KICK BEYOND MAXIMUM STROKE (PER TOOL & DIE SPACE) SINCE THAT WILL CAUSE FAILURE IN UPPER KNOCKOUT MECHANISM.
